Operating Experience Weekly Summary 97-34

August 15 through August 21, 1997

1. O-RING FAILURE CAUSES ACID SPILL

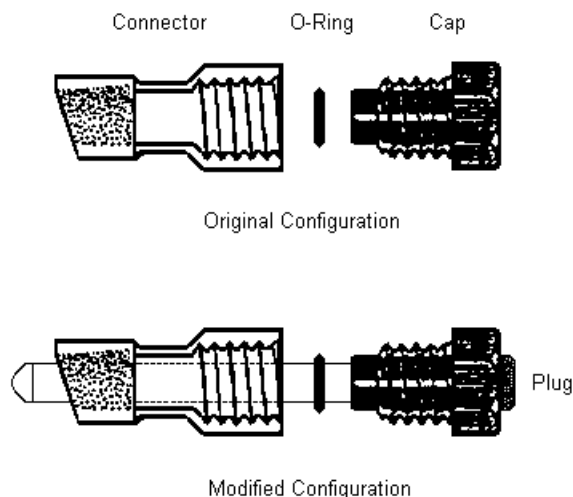
The reaction vessel contained approximately 15 liters of phosphoric acid (85 percent concentration) and 400 ml of nitric acid (70 percent concentration). The vessel design incorporates penetrations that allow researchers to add test materials and insert instruments and equipment. Figure 1-1 shows the original and modified configuration of the o-ring seal. The researcher heated and pressurized the vessel to approximately 8.6 pounds per square inch and 150 degrees Celsius. When he pressurized the vessel, the plug (held by the o-ring) inside a 2-inch connector slid through the o-ring. This caused a rapid pressure release and foaming of the acid, which resulted in the plug and acid shooting into the room.

Figure 1-1. Original and Modified Configurations of O-Ring Seal

Investigators continue to investigate to determine the exact cause of the o-ring seal failure. They initiated a design review and are also investigating to determine whether water in the o-ring could have contributed to the failure. They also determined that the o-rings were not part of a preventive maintenance inspection program. In addition to the investigation and design review, facility managers directed laboratory personnel to implement the following actions.

- Clean-up the acid.
- Prepare and distribute a lessons learned report.
- Repair the electrical outlet.
- Develop instructions for pressure-testing o-rings seals, including guidance for seal maintenance and inspection.
- Develop an emergency electrical shutdown procedure.
